BUREAU OF SHIPS GROUP TECHNICAL INSPECTION REPORT

U.S.S. INDEPENDENCE (CVL22)

TEST ABLE

VOLUME 4 OF 4

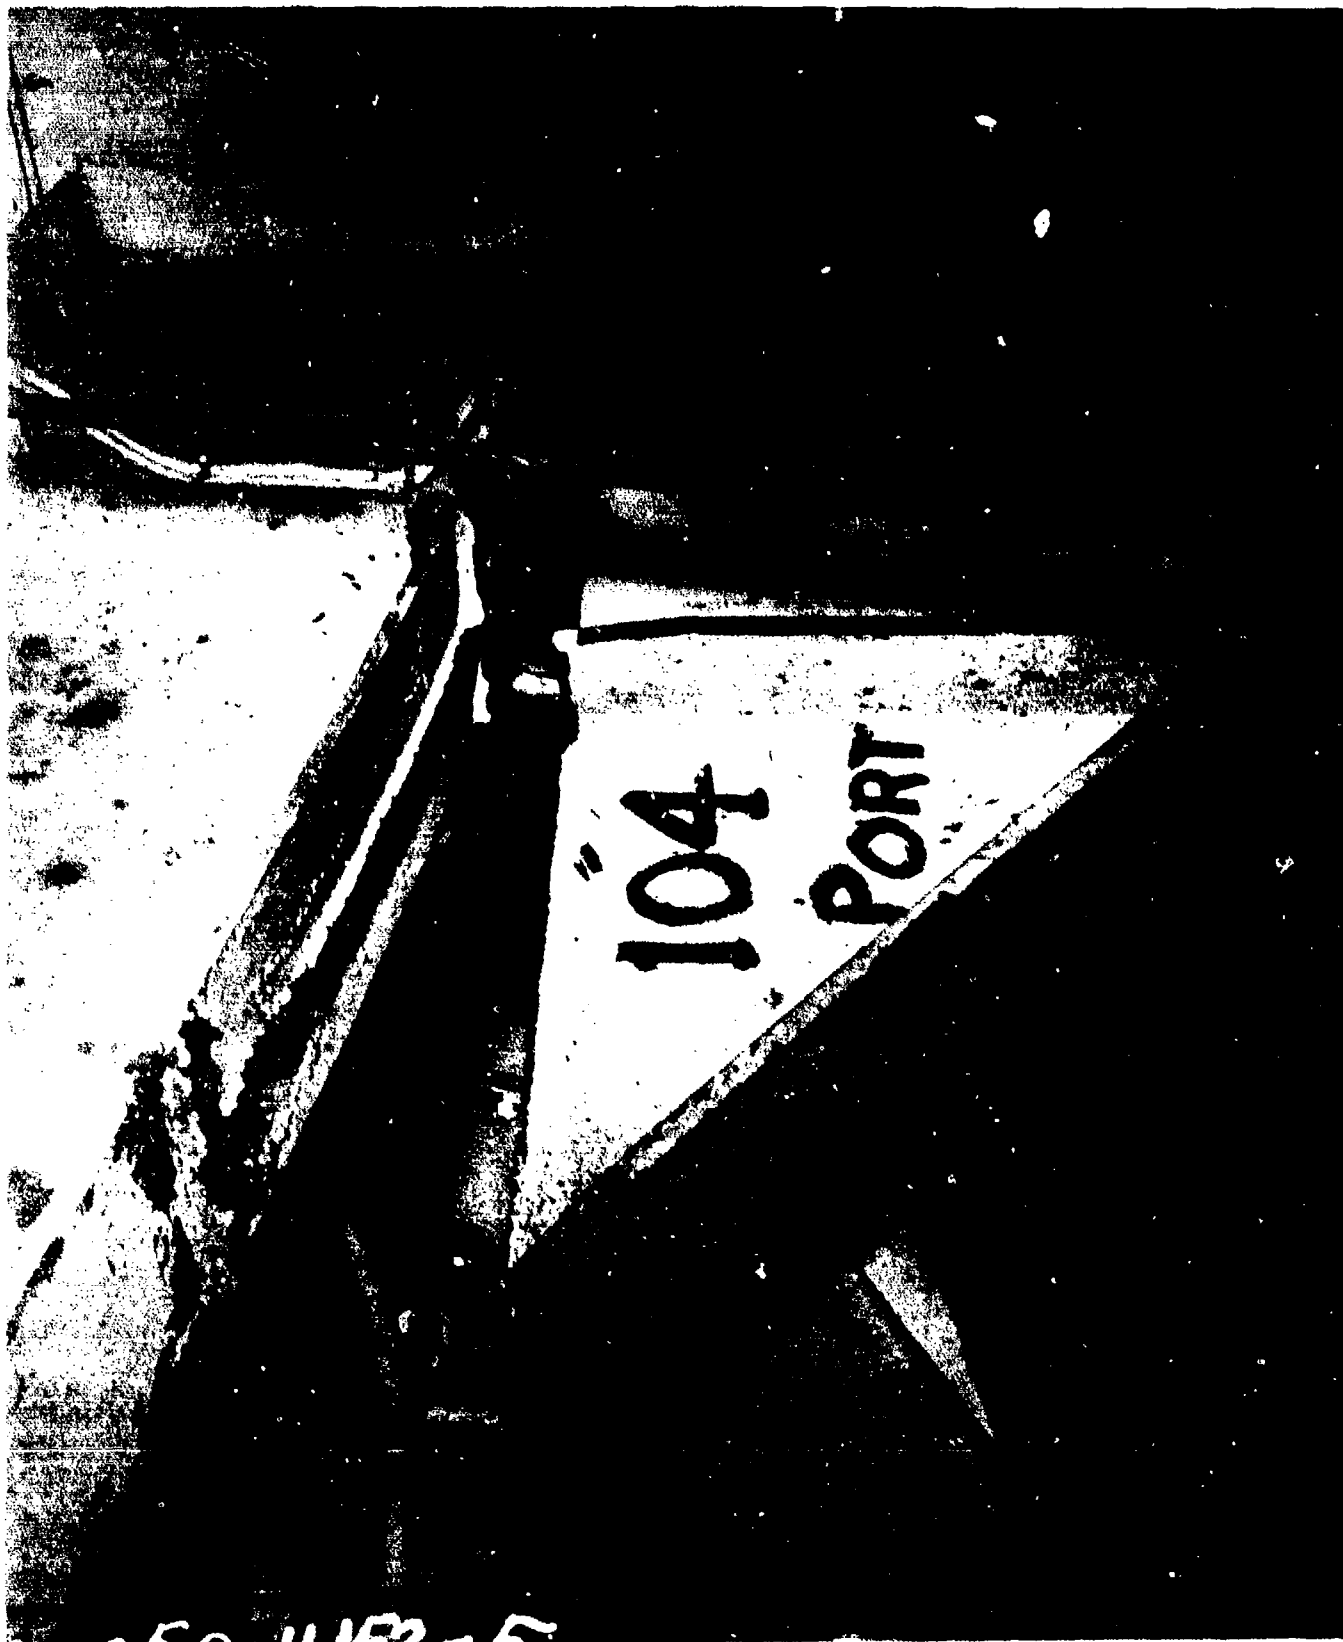
AA-CR-59-4152-5. Flight deck Bent 104, port side overhead connection, showing failure of weld along upper edge of bracket and column. Looking aft.

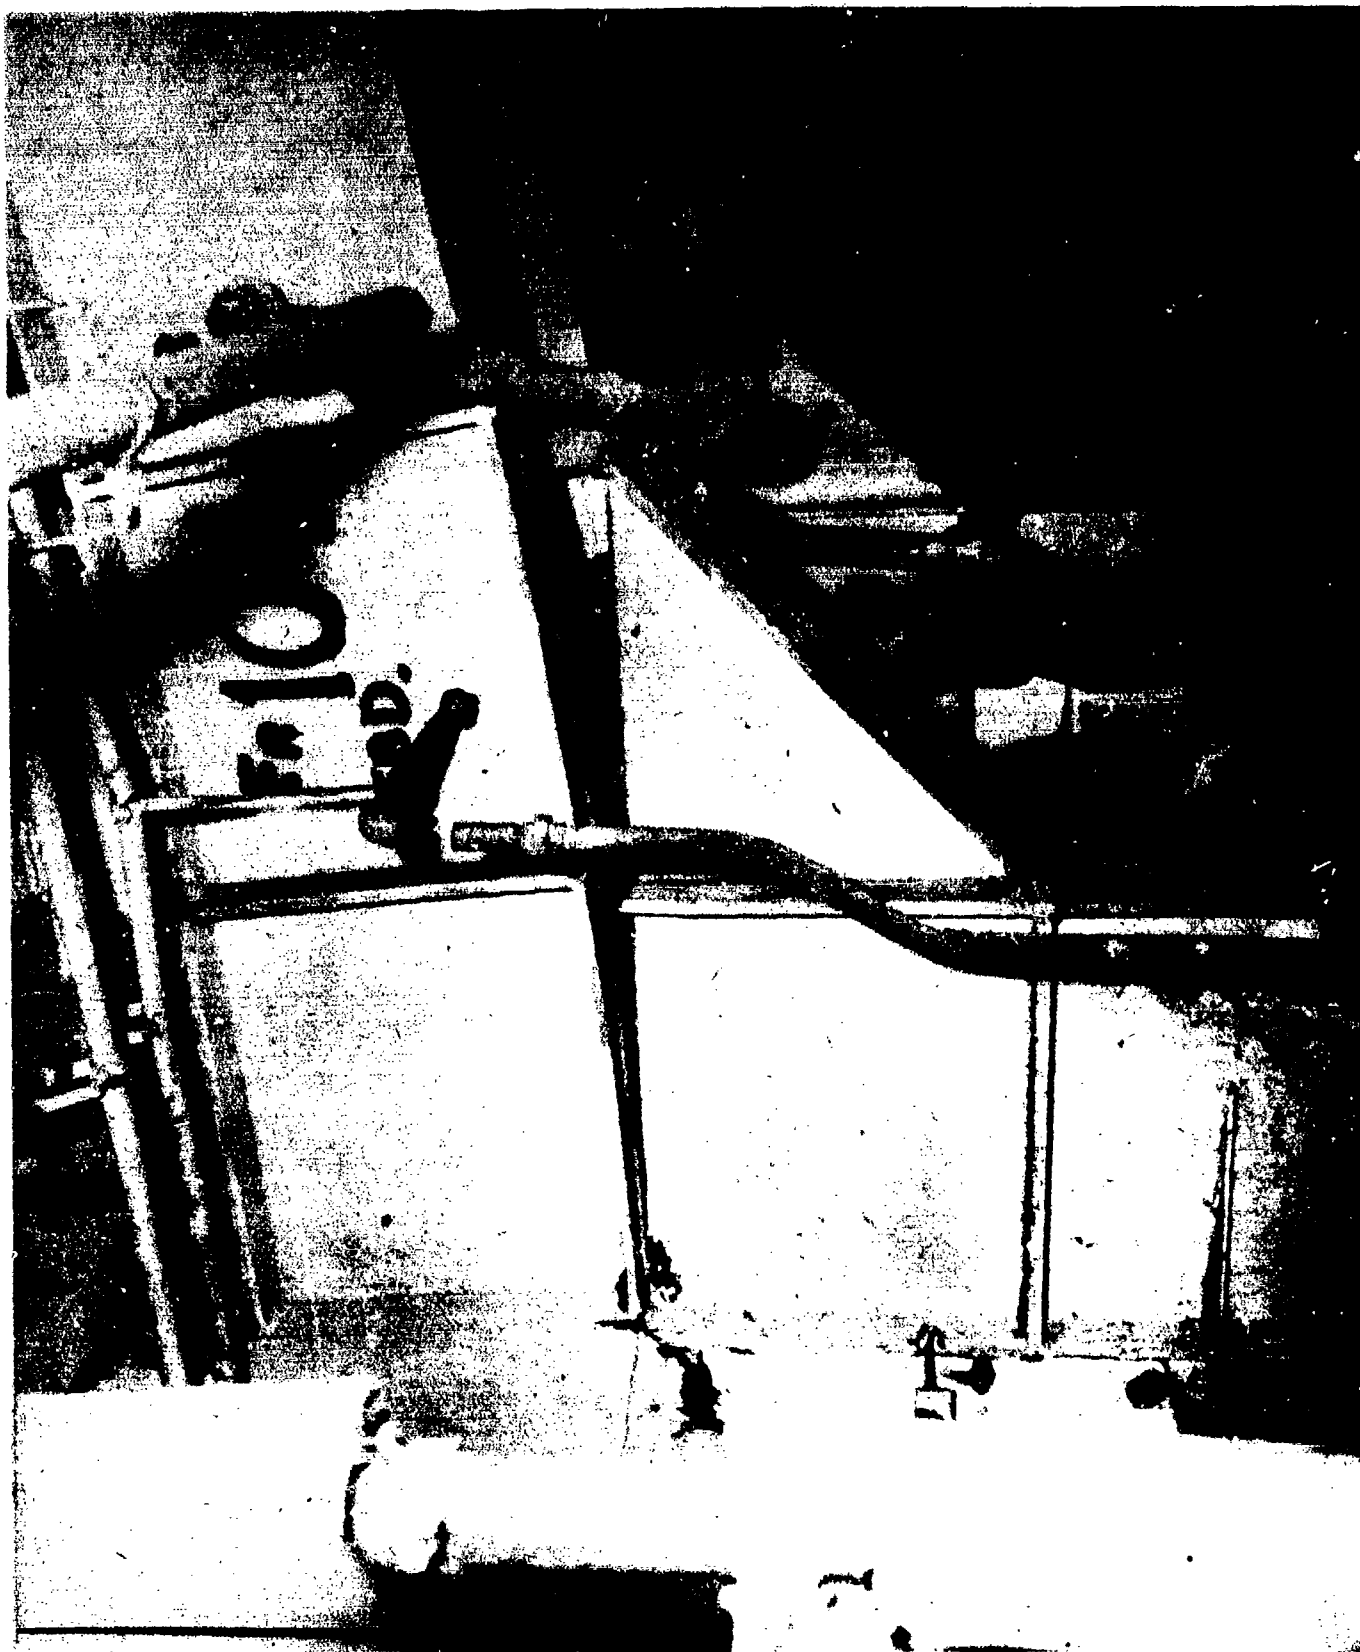
AA-CR-59-4149-11. Flight deck Bent 104, starboard overhead, connection showing failure of welded joint. Looking aft.

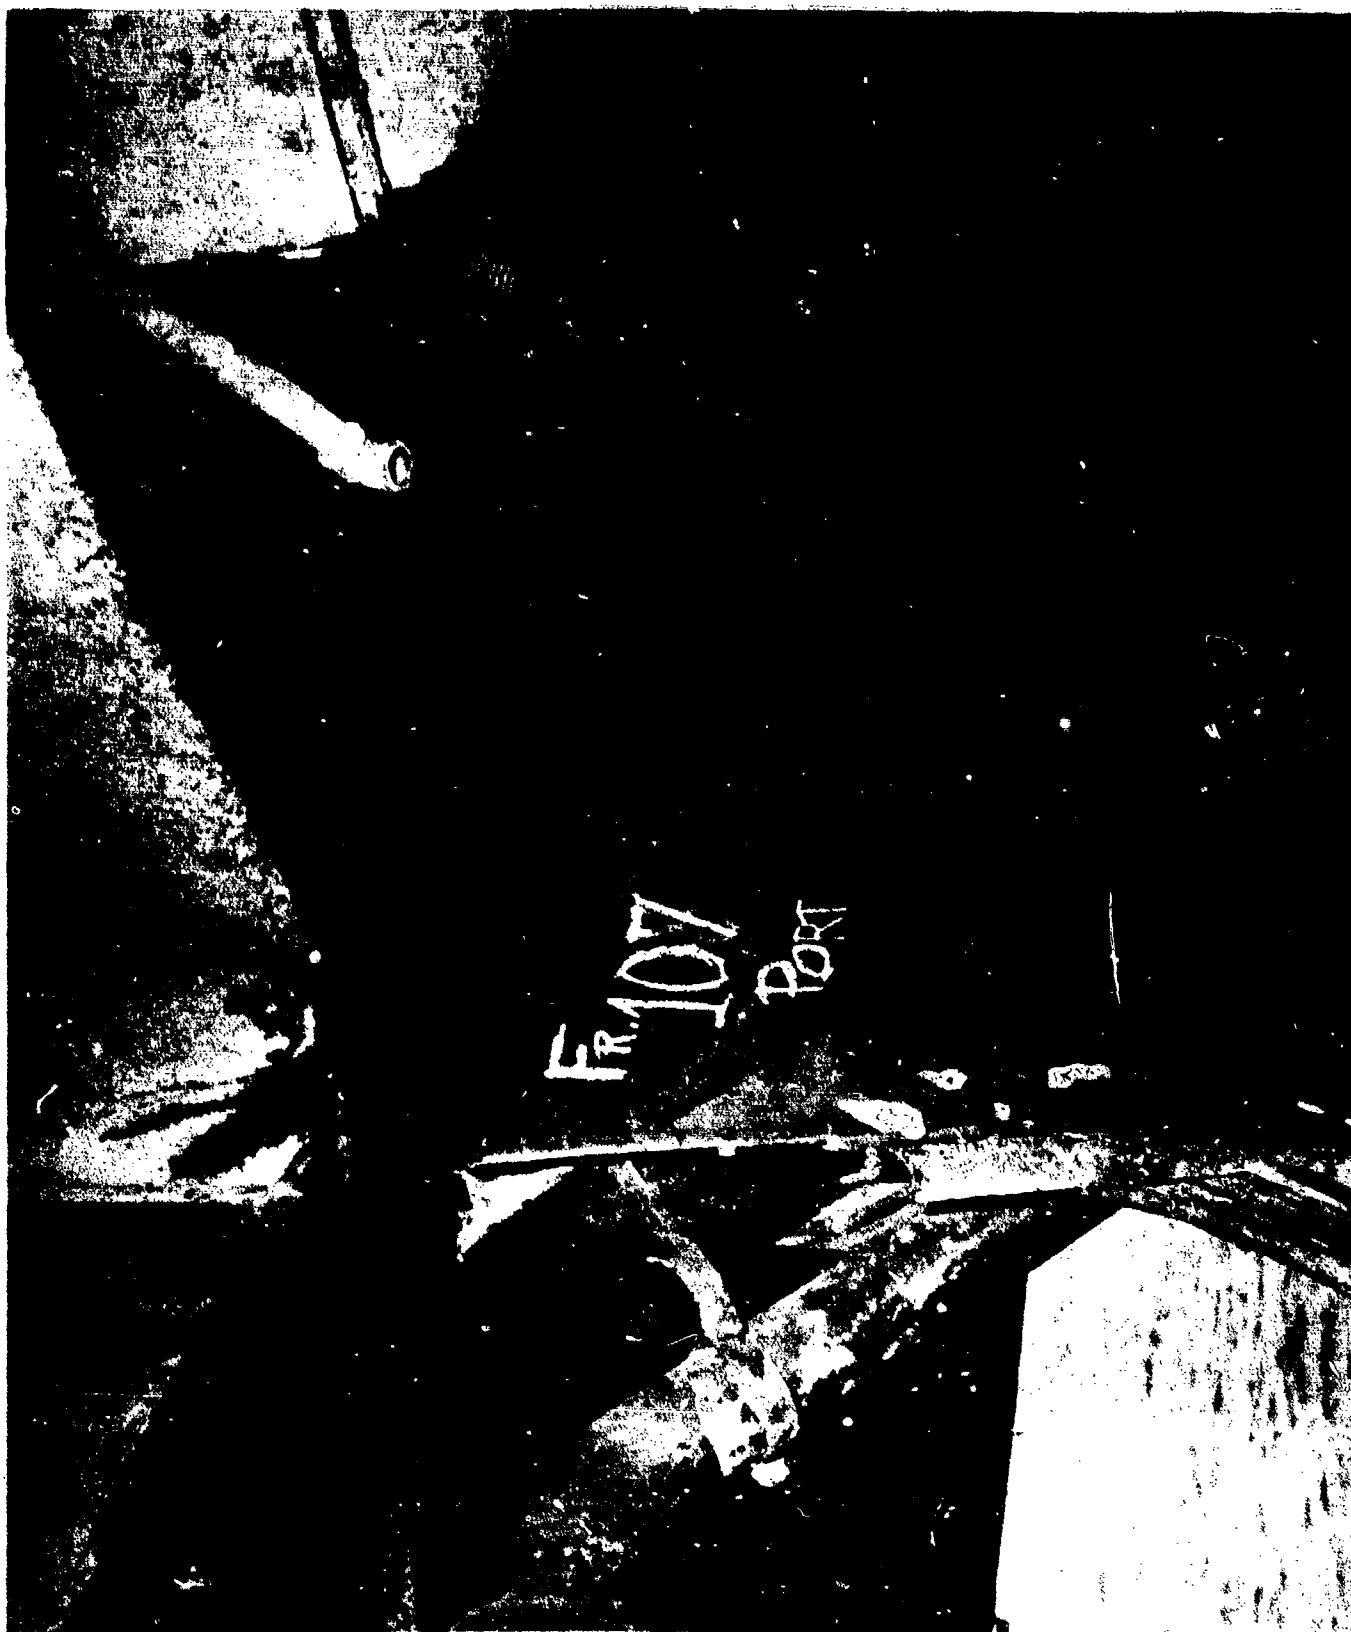
AA-CR-59-4152-4. Flight deck Bent 107, port overhead connection, showing failure of weld along upper edge of bracket. Looking aft.

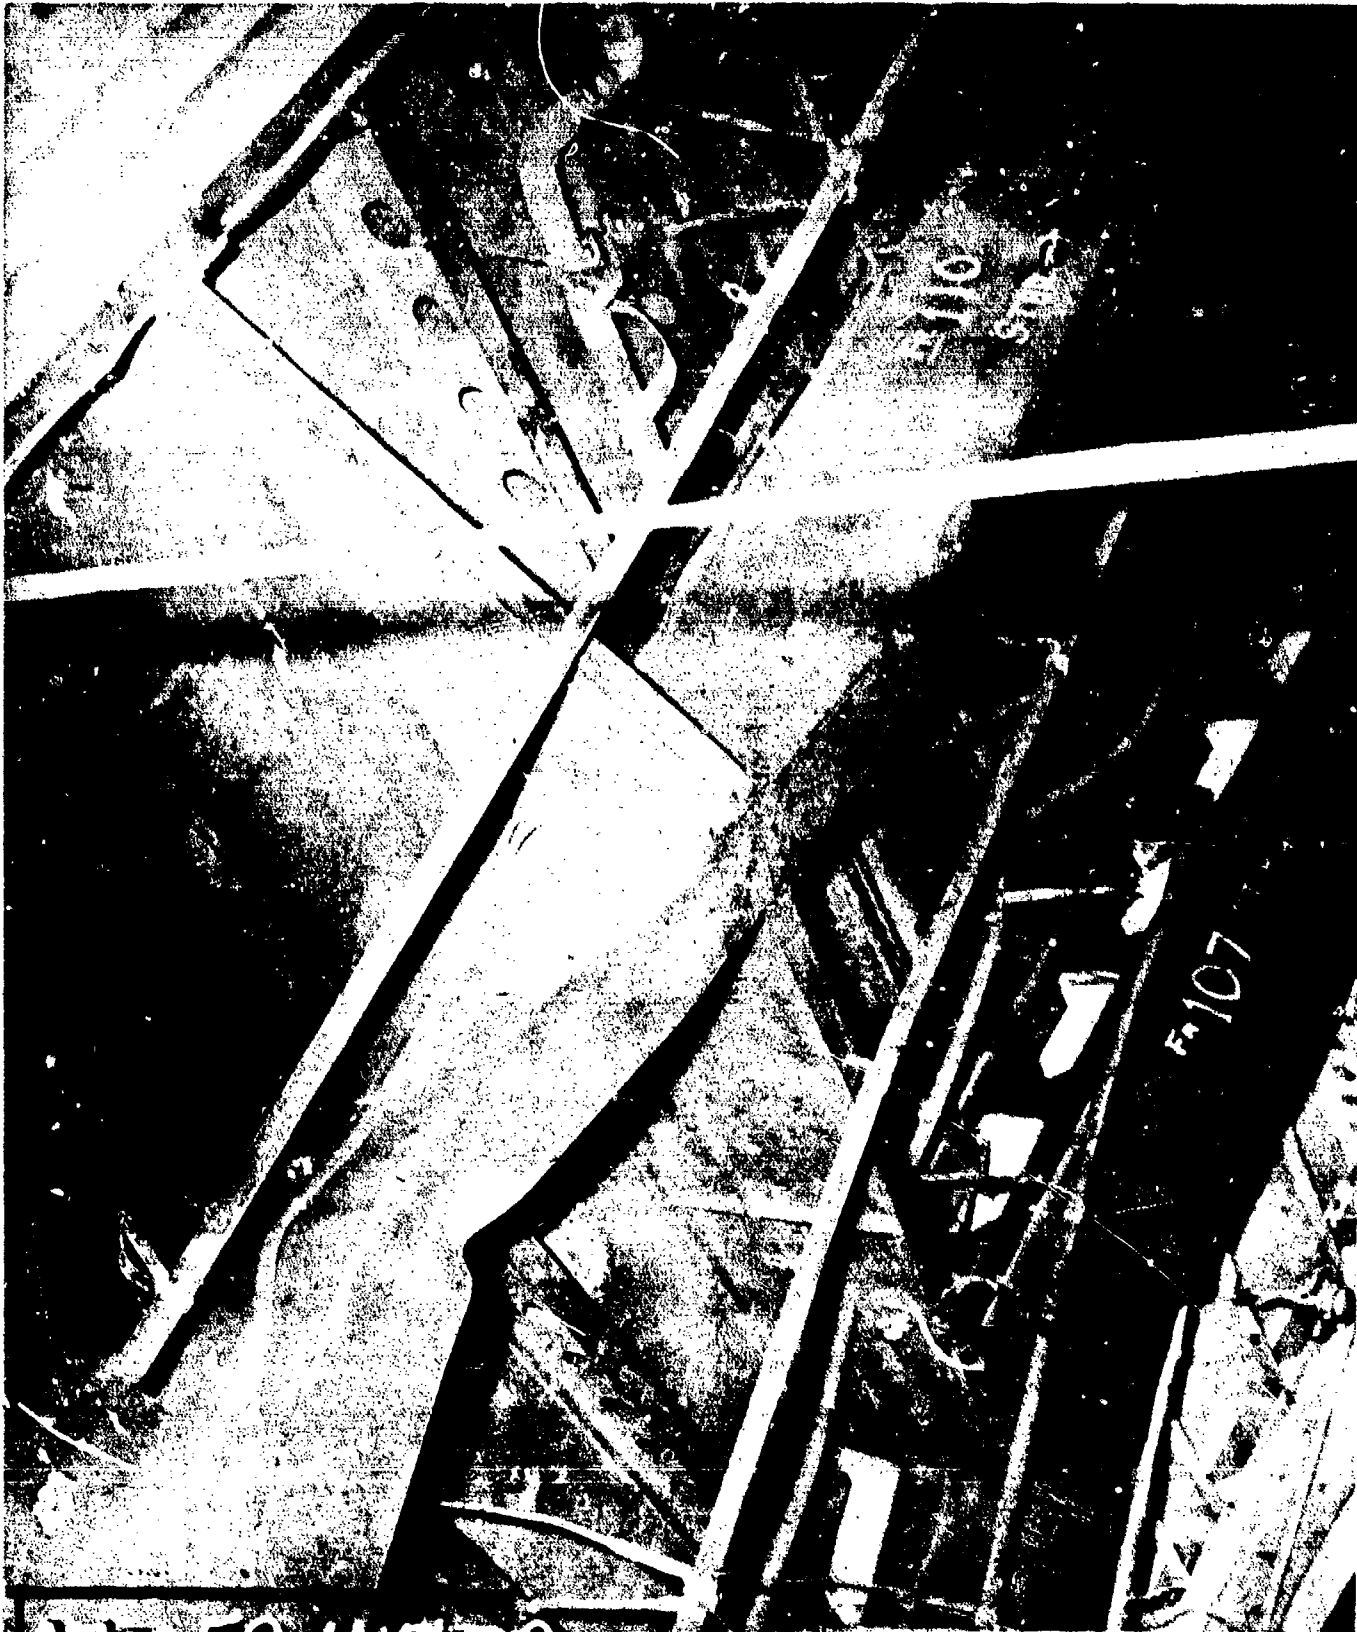
AA-CR-59-4151-9. Flight deck bent girders 104, 107 and 110, showing failures near centerline. Looking forward and to starboard.

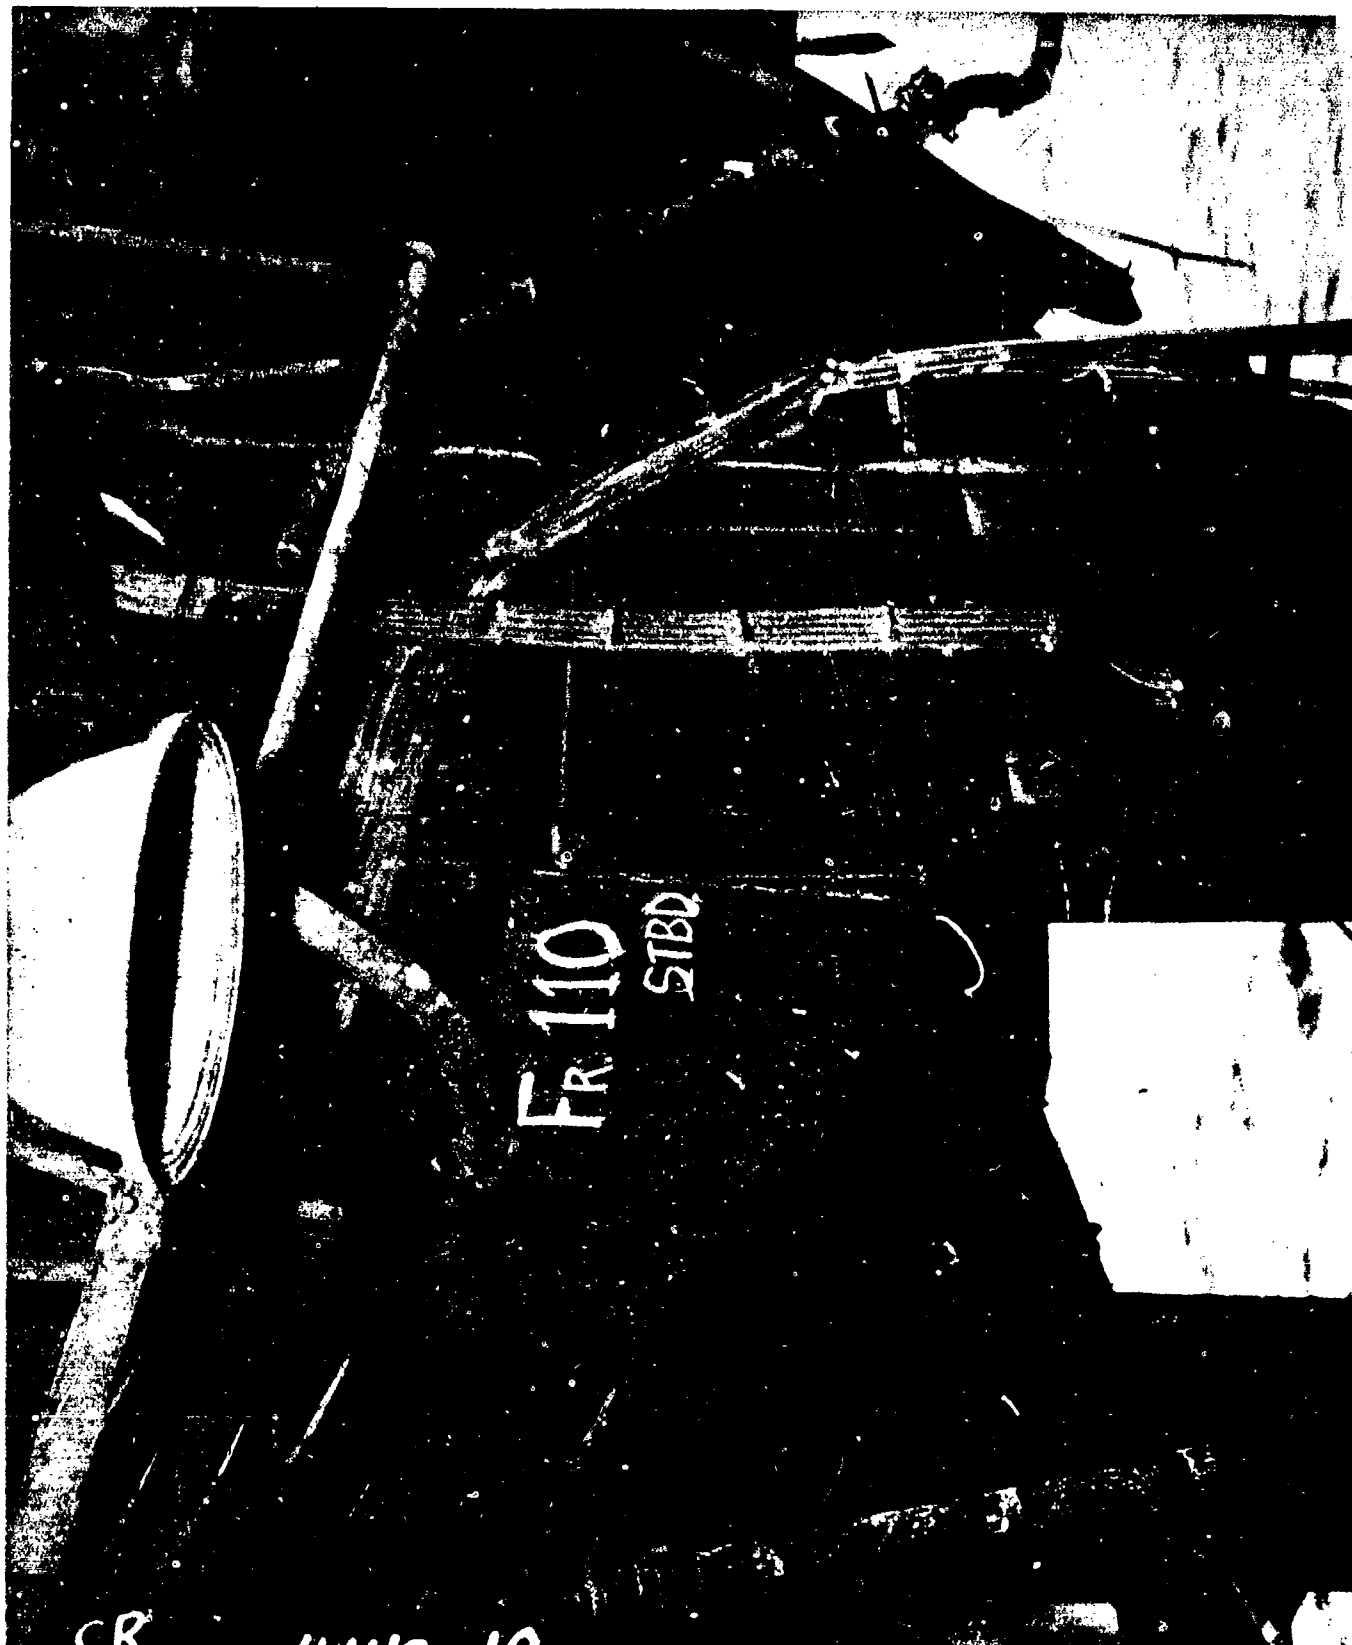
AA-CR-59-4149-12. Flight deck Bent 110, starboard overhead connection, showing failure of welds at vertical and horizontal joints. Locking forward.

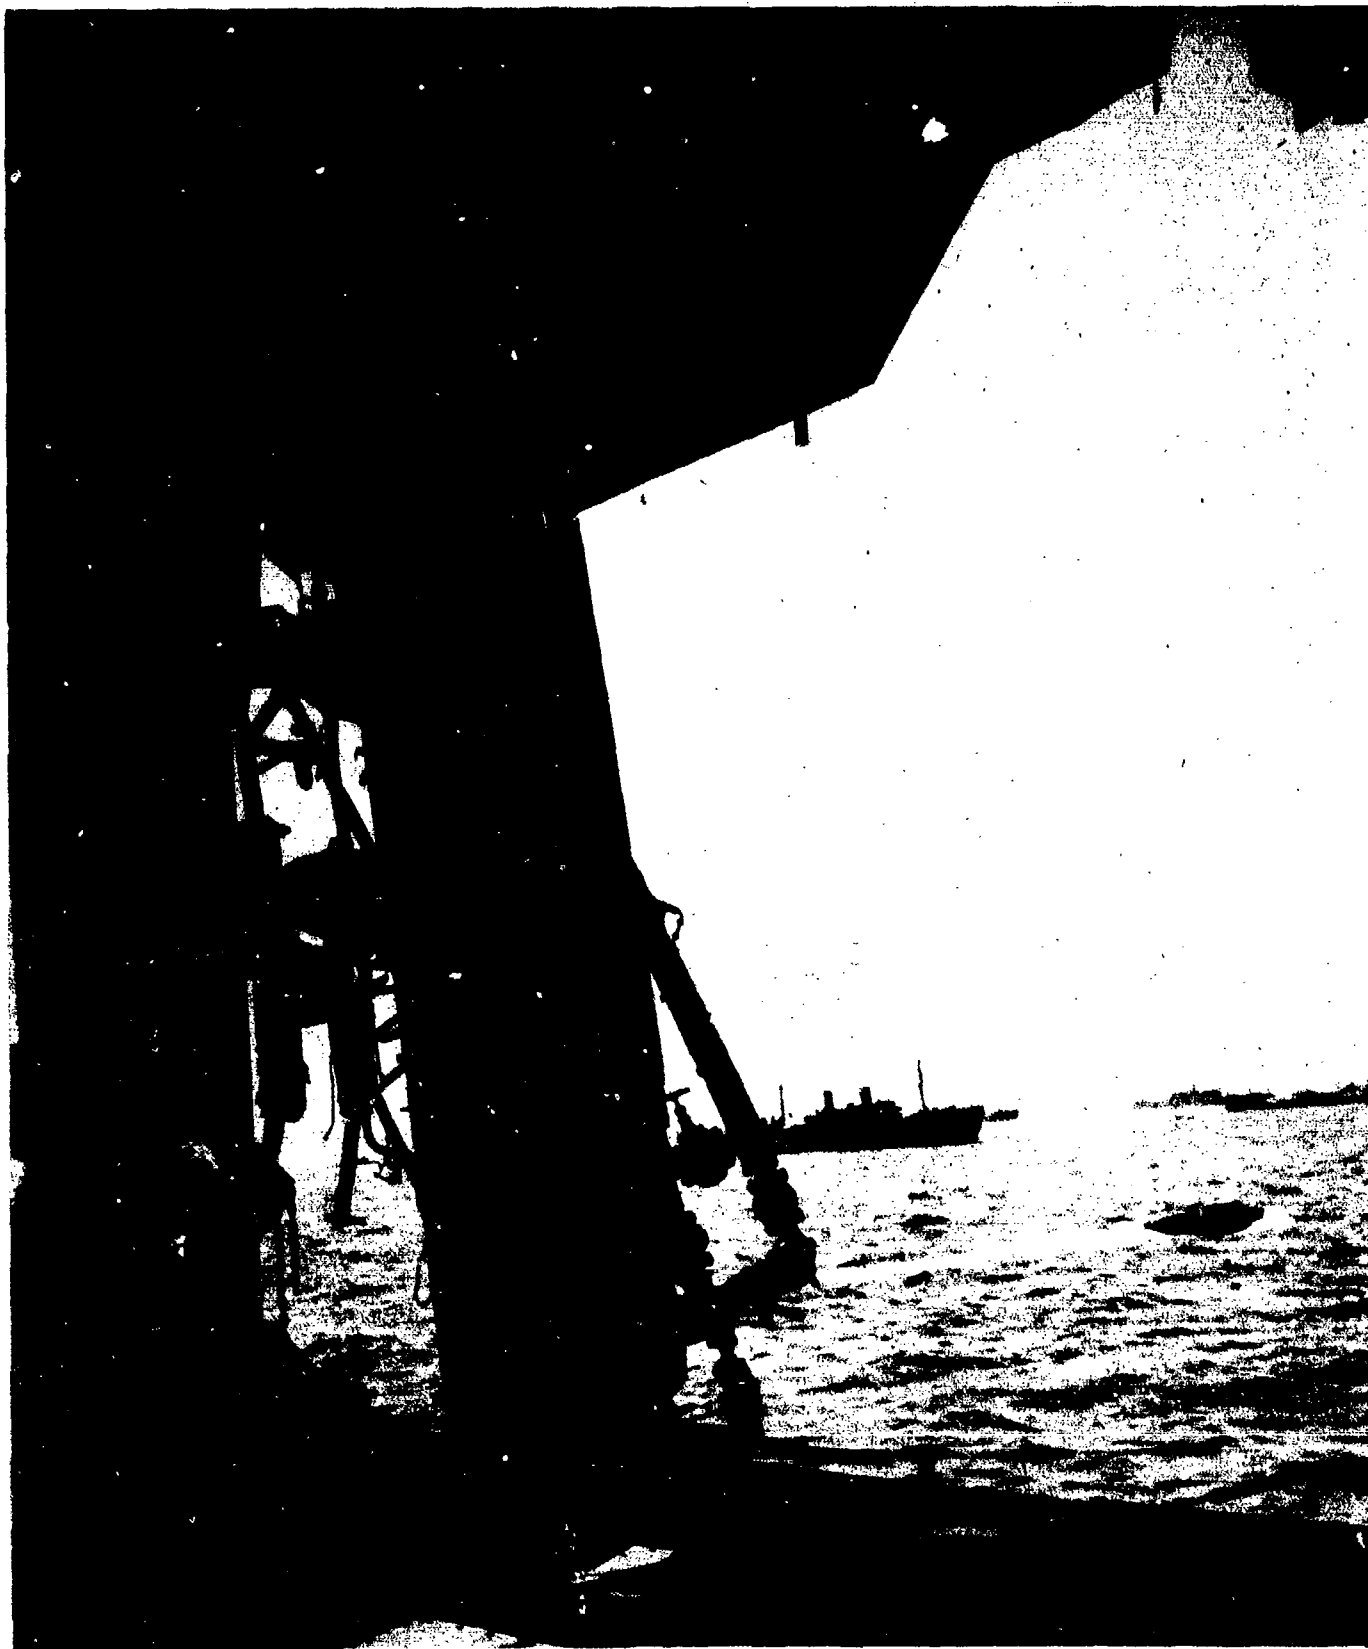
AA-CR-59-4153-1. Flight deck Wobble Bents 113 and 115, port side, looking aft and to port. Note failure of deck pad at 113.

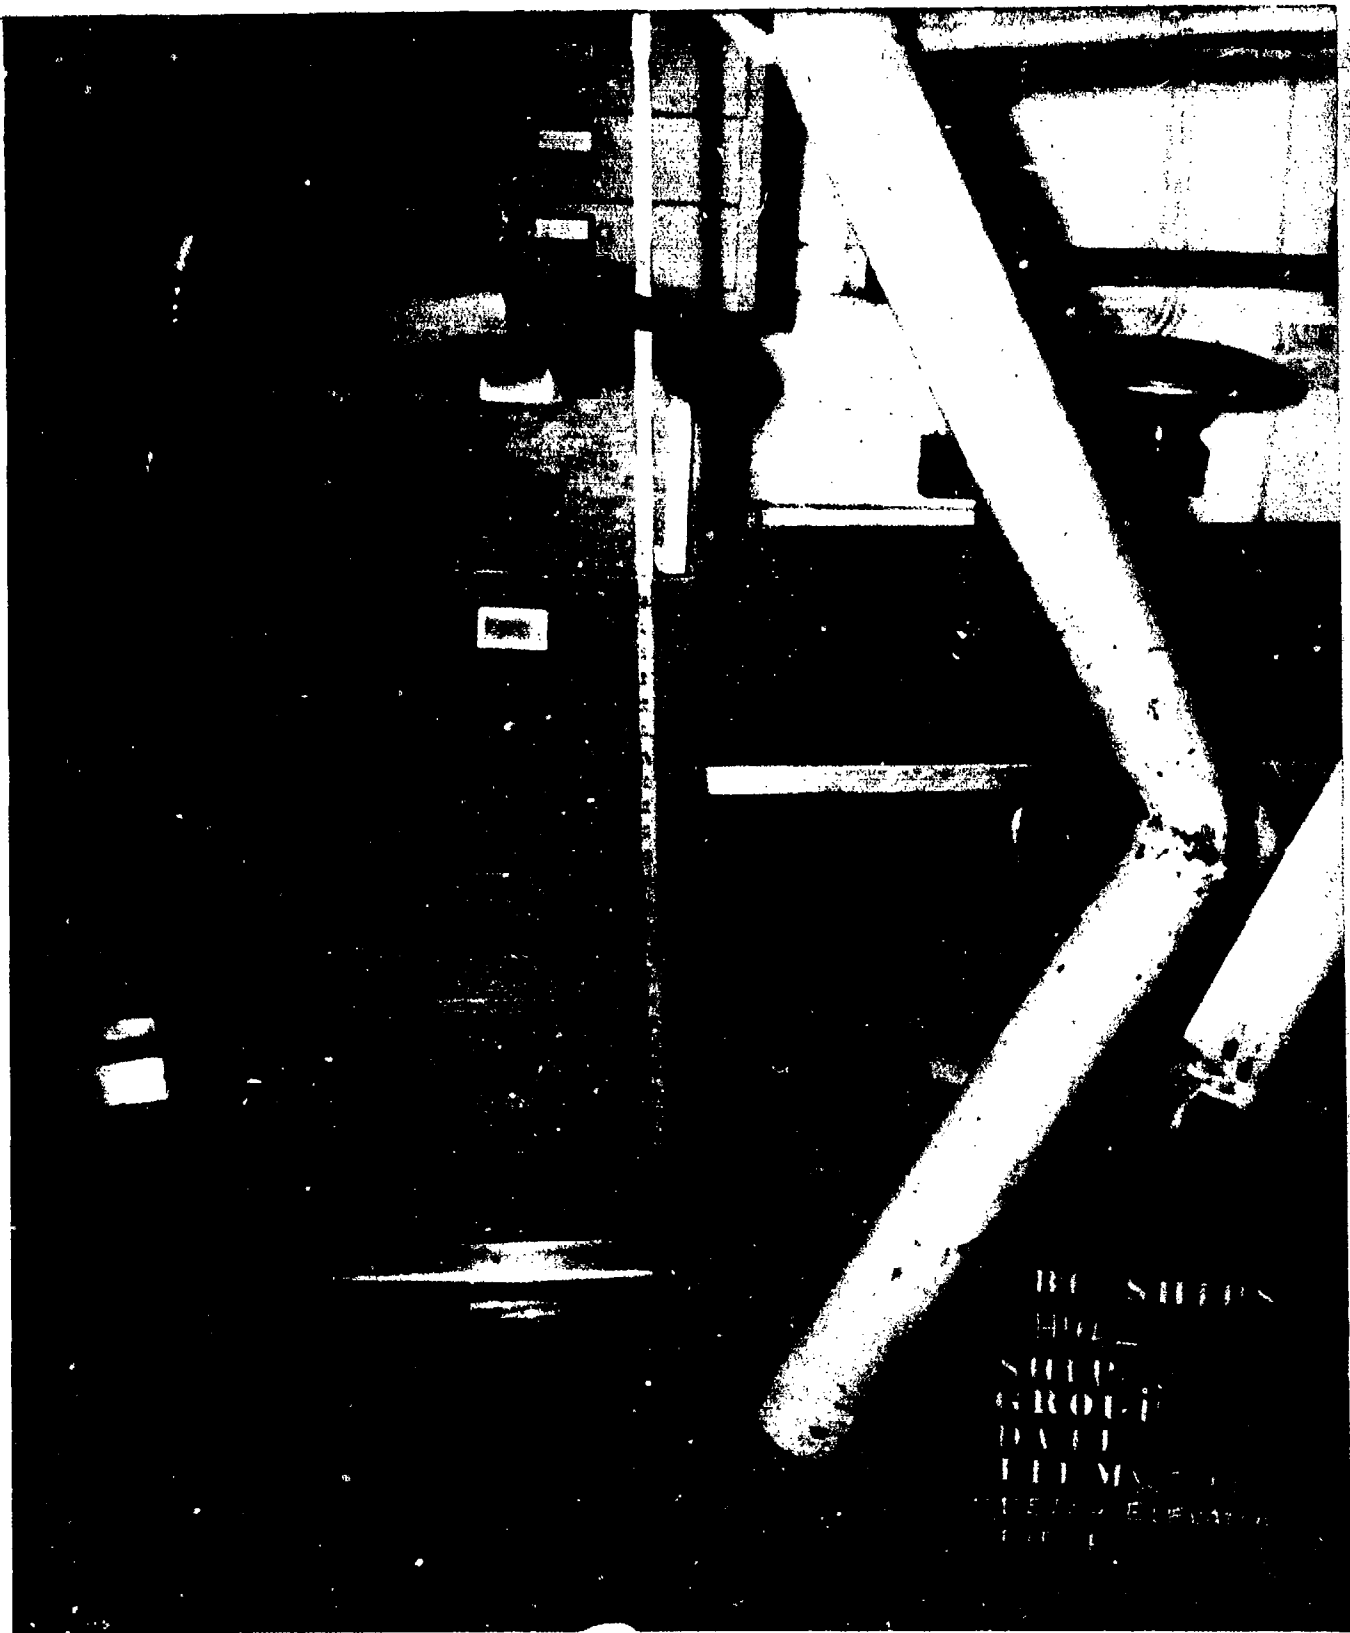
AA-CR-88-2100-9. Second deck, supply office, A-211-1, showing depression of overhead below forward elevator pit, buckled quarter span stanchion, frame 53, and weld failures between stanchion overhead and deck. Looking aft.

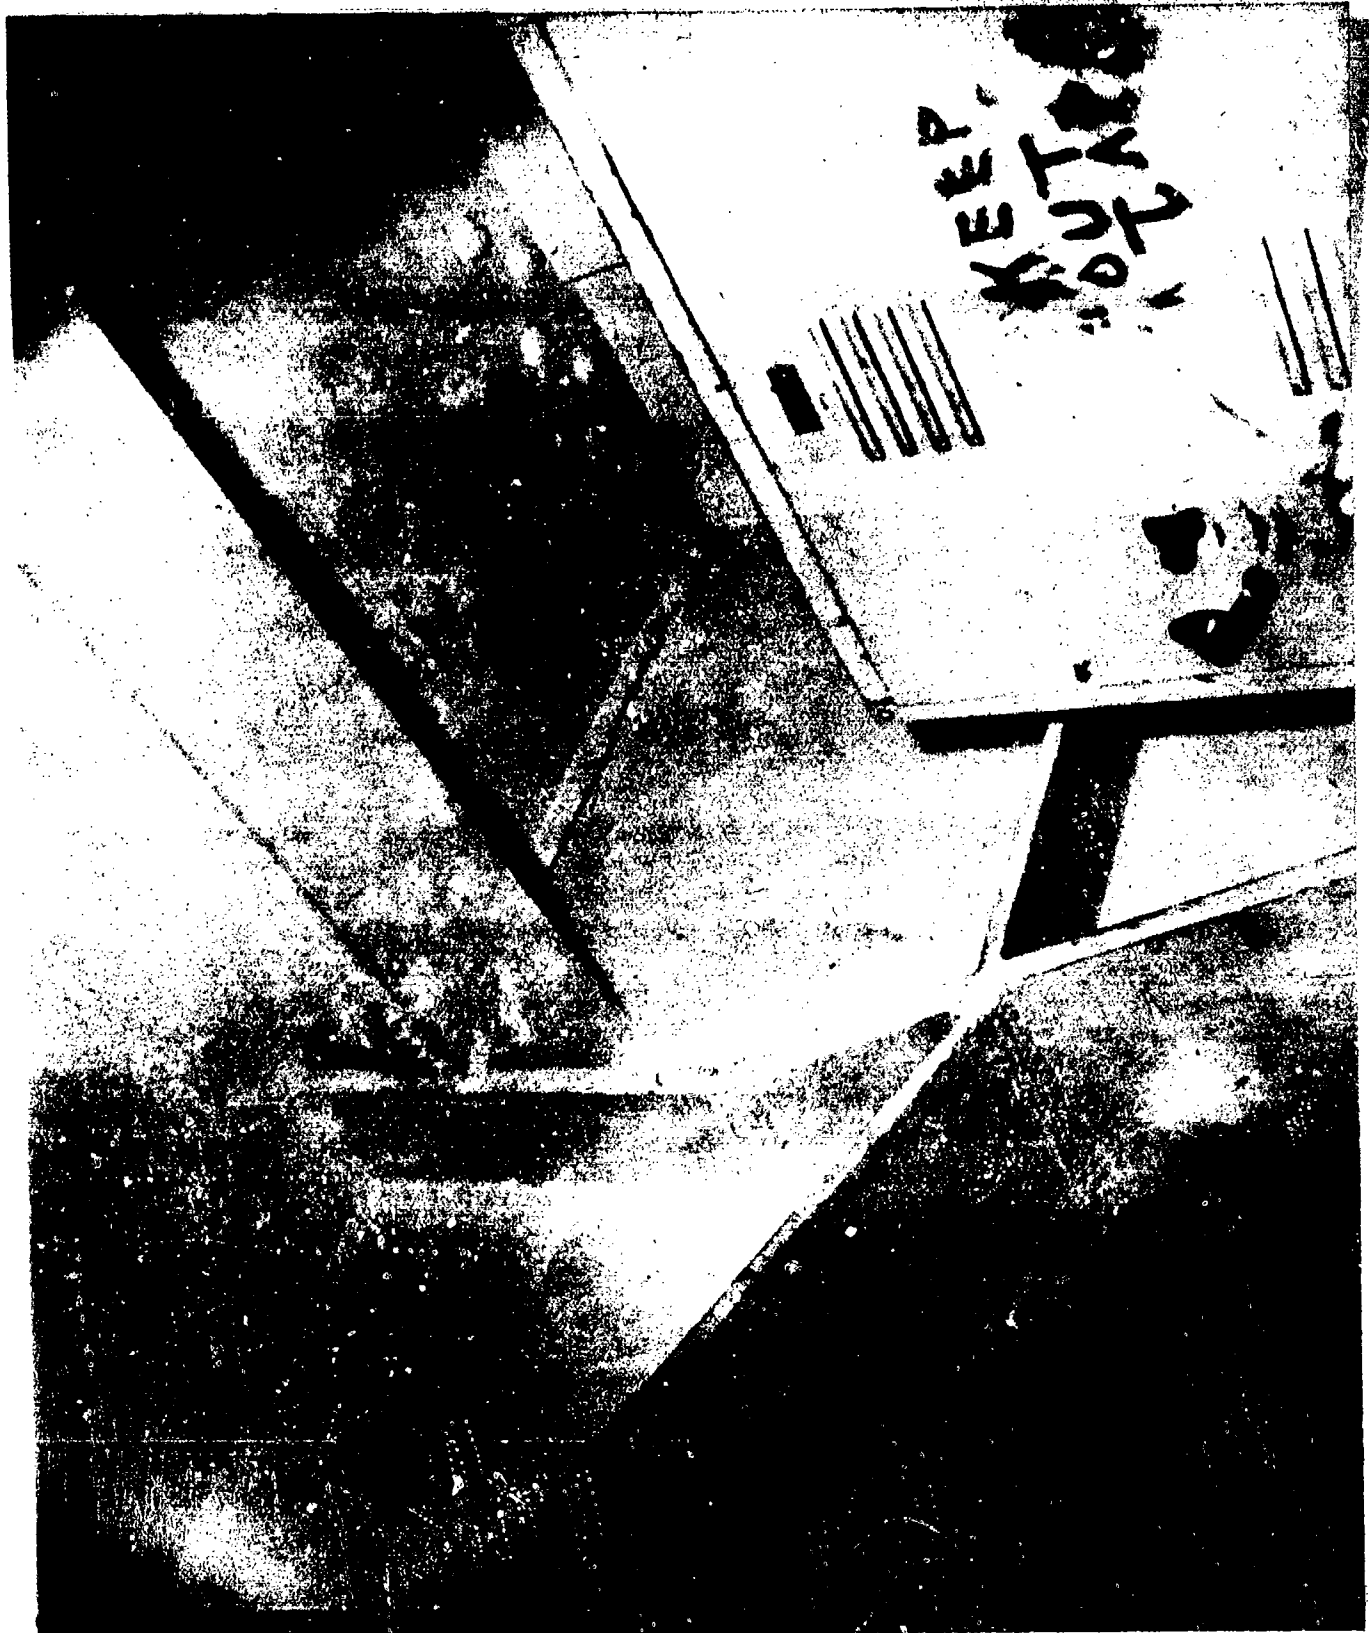
AA-CR-59-2088-7. Second deck, B-203-L. Failure of arc welded connection between port web frame 89, and S.T.S. stringer strake. Looking aft and outboard.

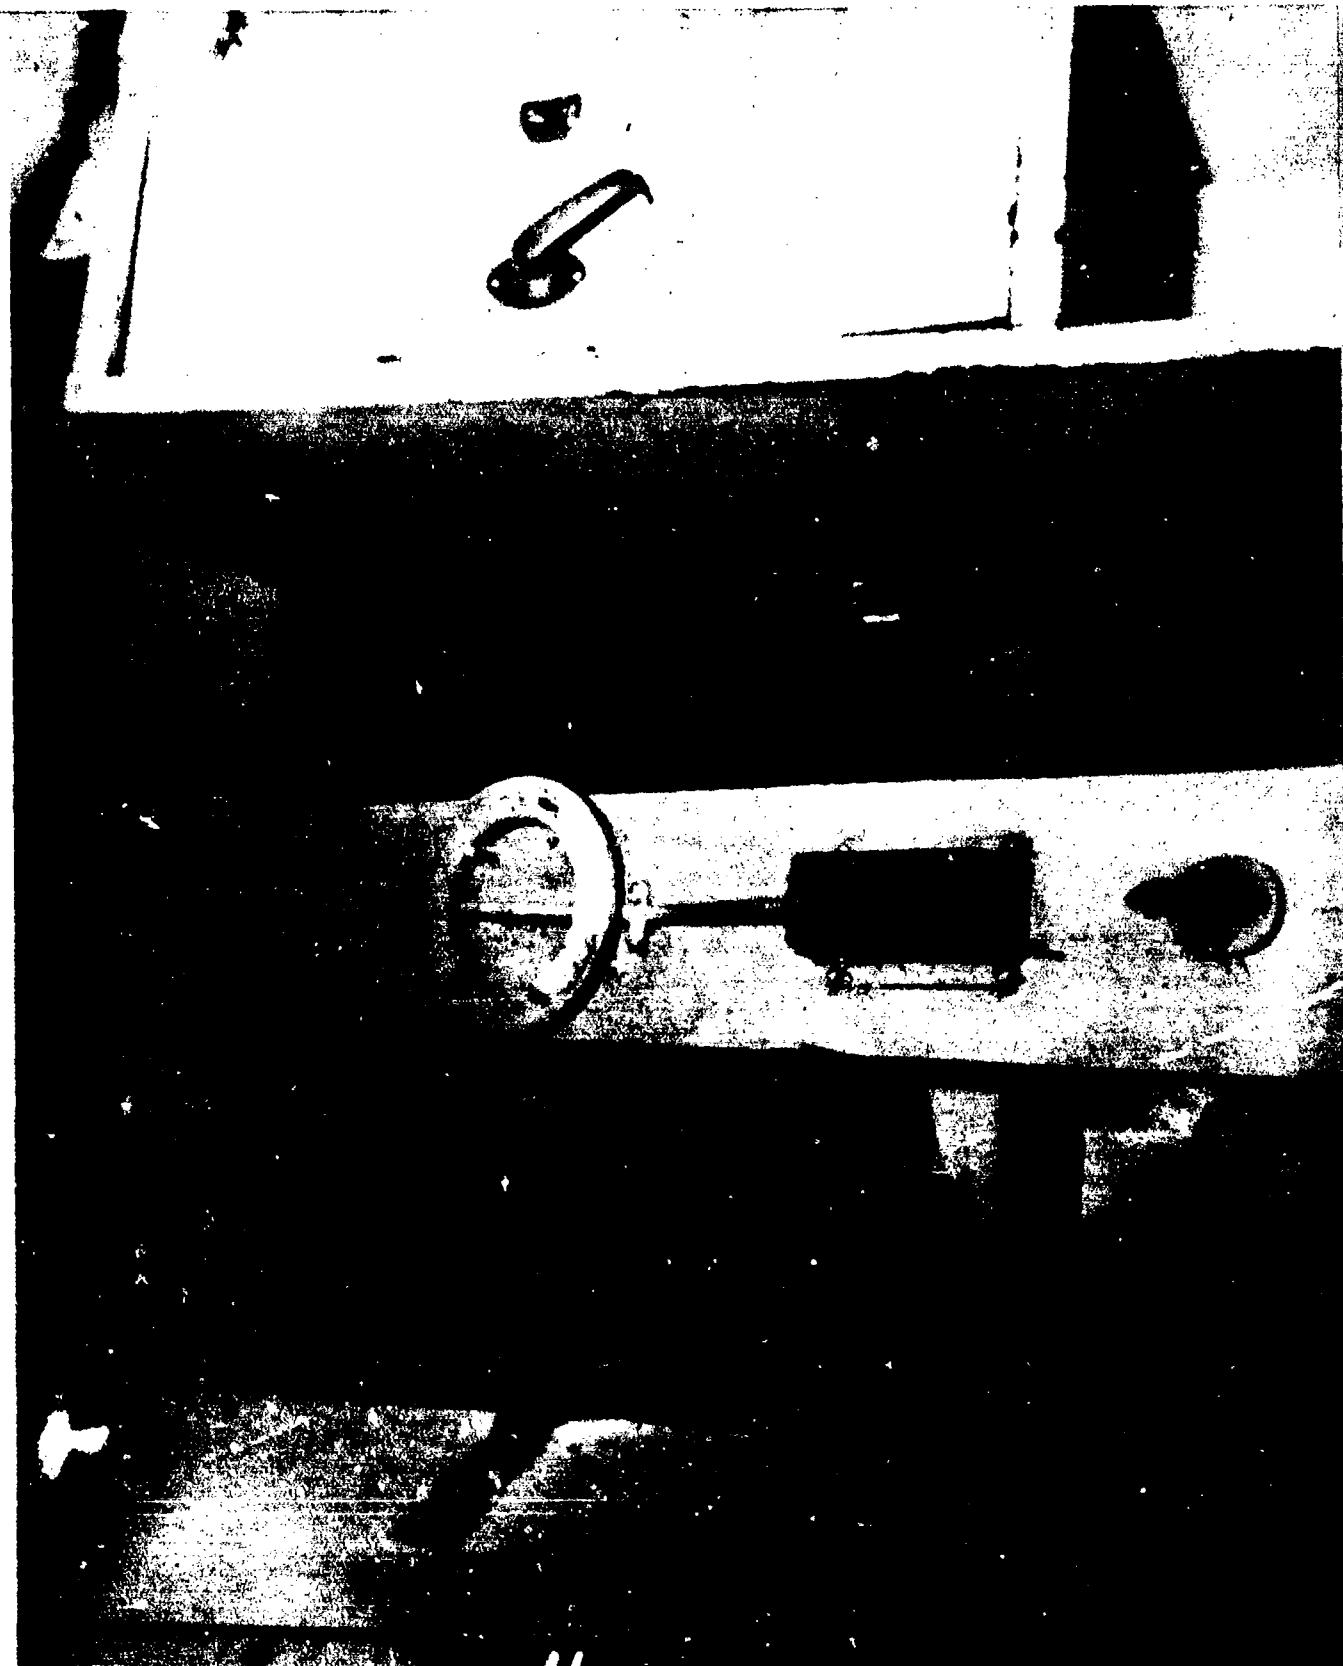
AA-CR-175-2118-4. Second deck. Stern. Interior face of counter, showing loosened insulation.

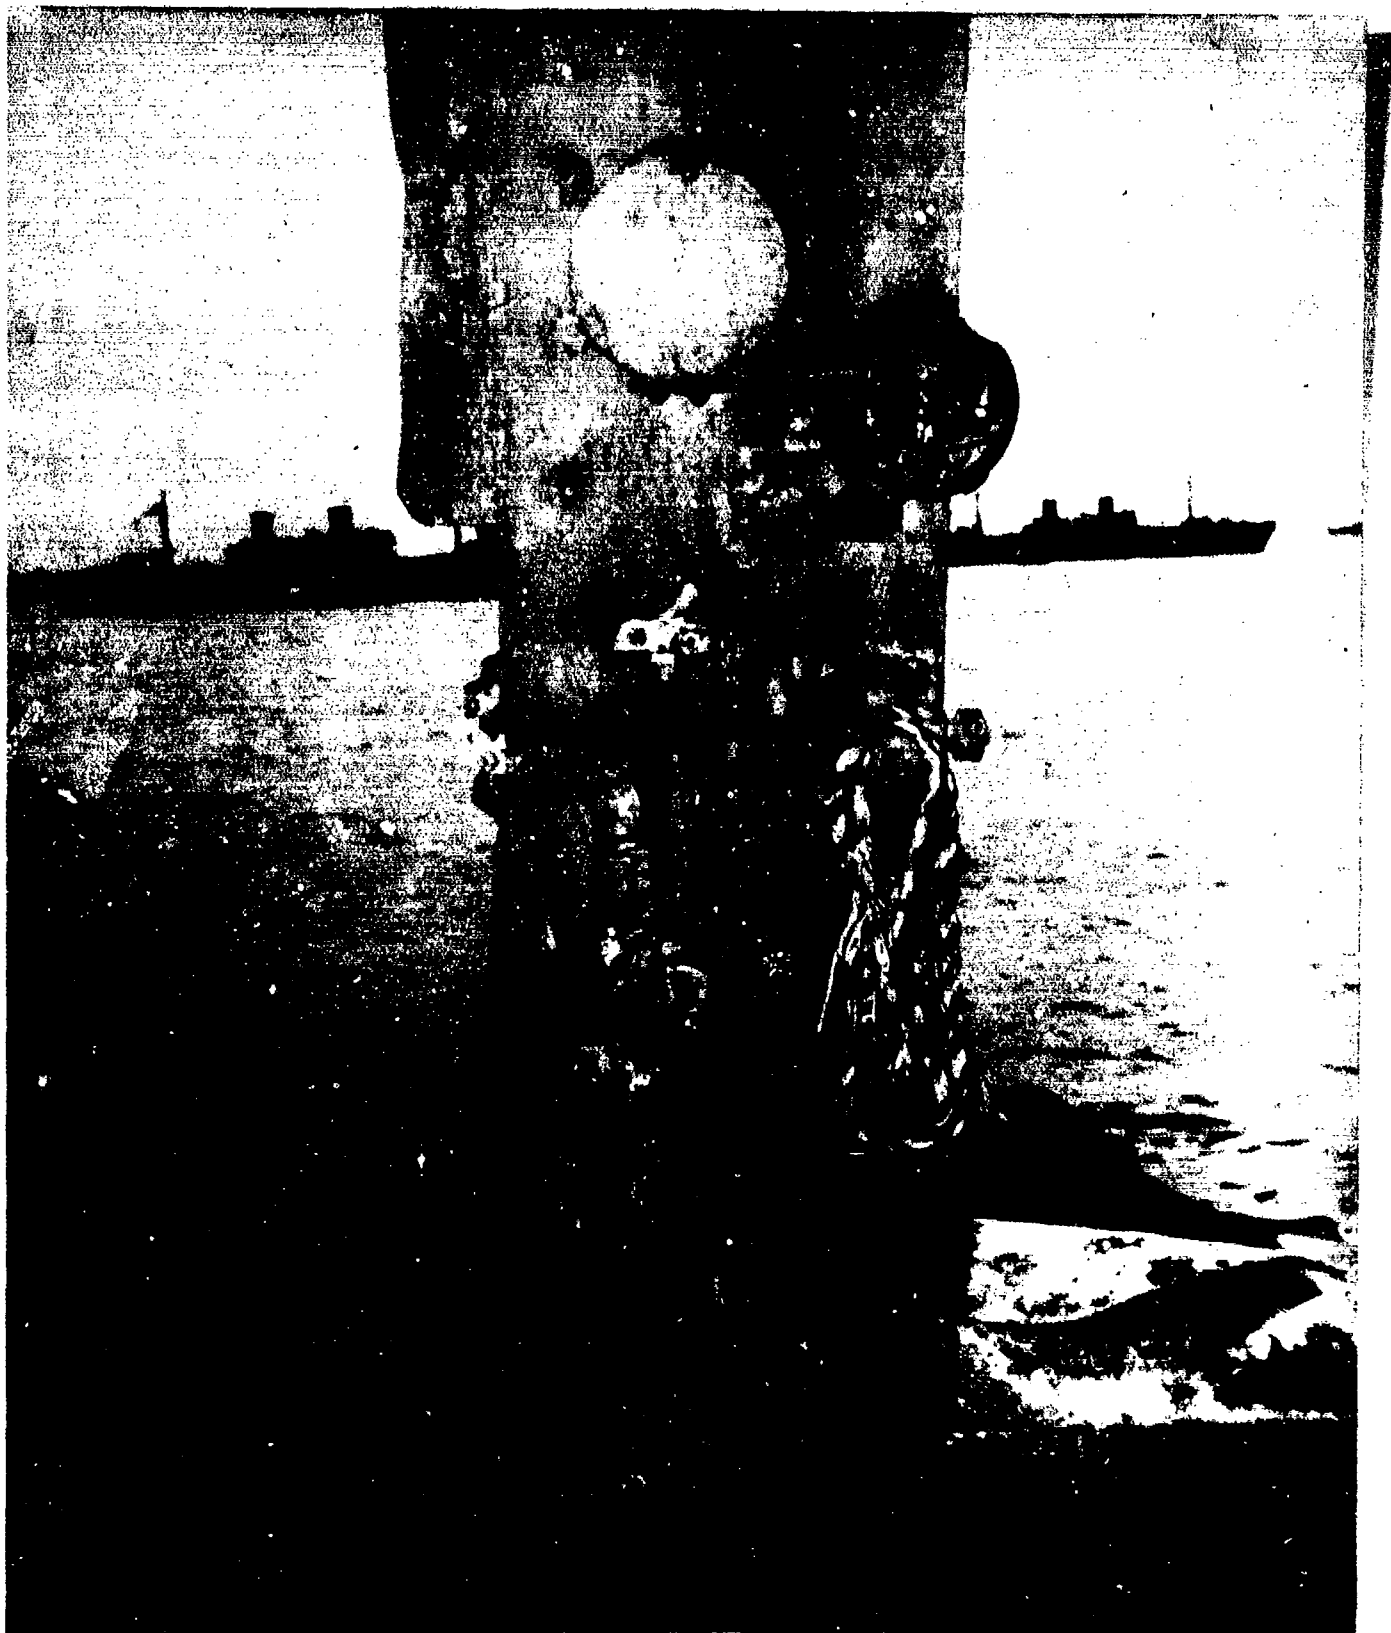
AA-CR-82-1918-7. Two power receptacles blown off foundation by blast pressure, located at frame 115 port side hangar space. View looking outboard.
